facilities study:

AUBURN PUBLIC SAFETY BUILDINGS

prepared for: **City of Auburn** 60 Court Street Auburn, Maine

December 15, 2020

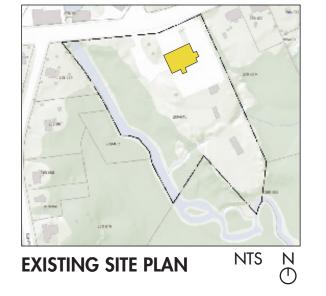
PROPOSED SITE PLAN:

- easily phased
- true shared facility with balance between programs
- requires adjacent private property

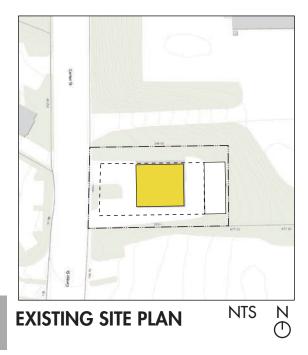
PROPOSED SITE PLAN:

- 3/4 + of existing building is retained
- requires temporary relocation of some Engine 5 living quarters for duration of construction
- aquisition of alternate parking and access recommended to rear or side required
- configuration shown is over setback
